completed prior to Burnt Mill
 Bridge repair - 2016 (?)

Historic Resource Survey Form
 PENNSYLVANIA HISTORICAL AND MUSEUM COMMISSION
 Bureau for Historic Preservation

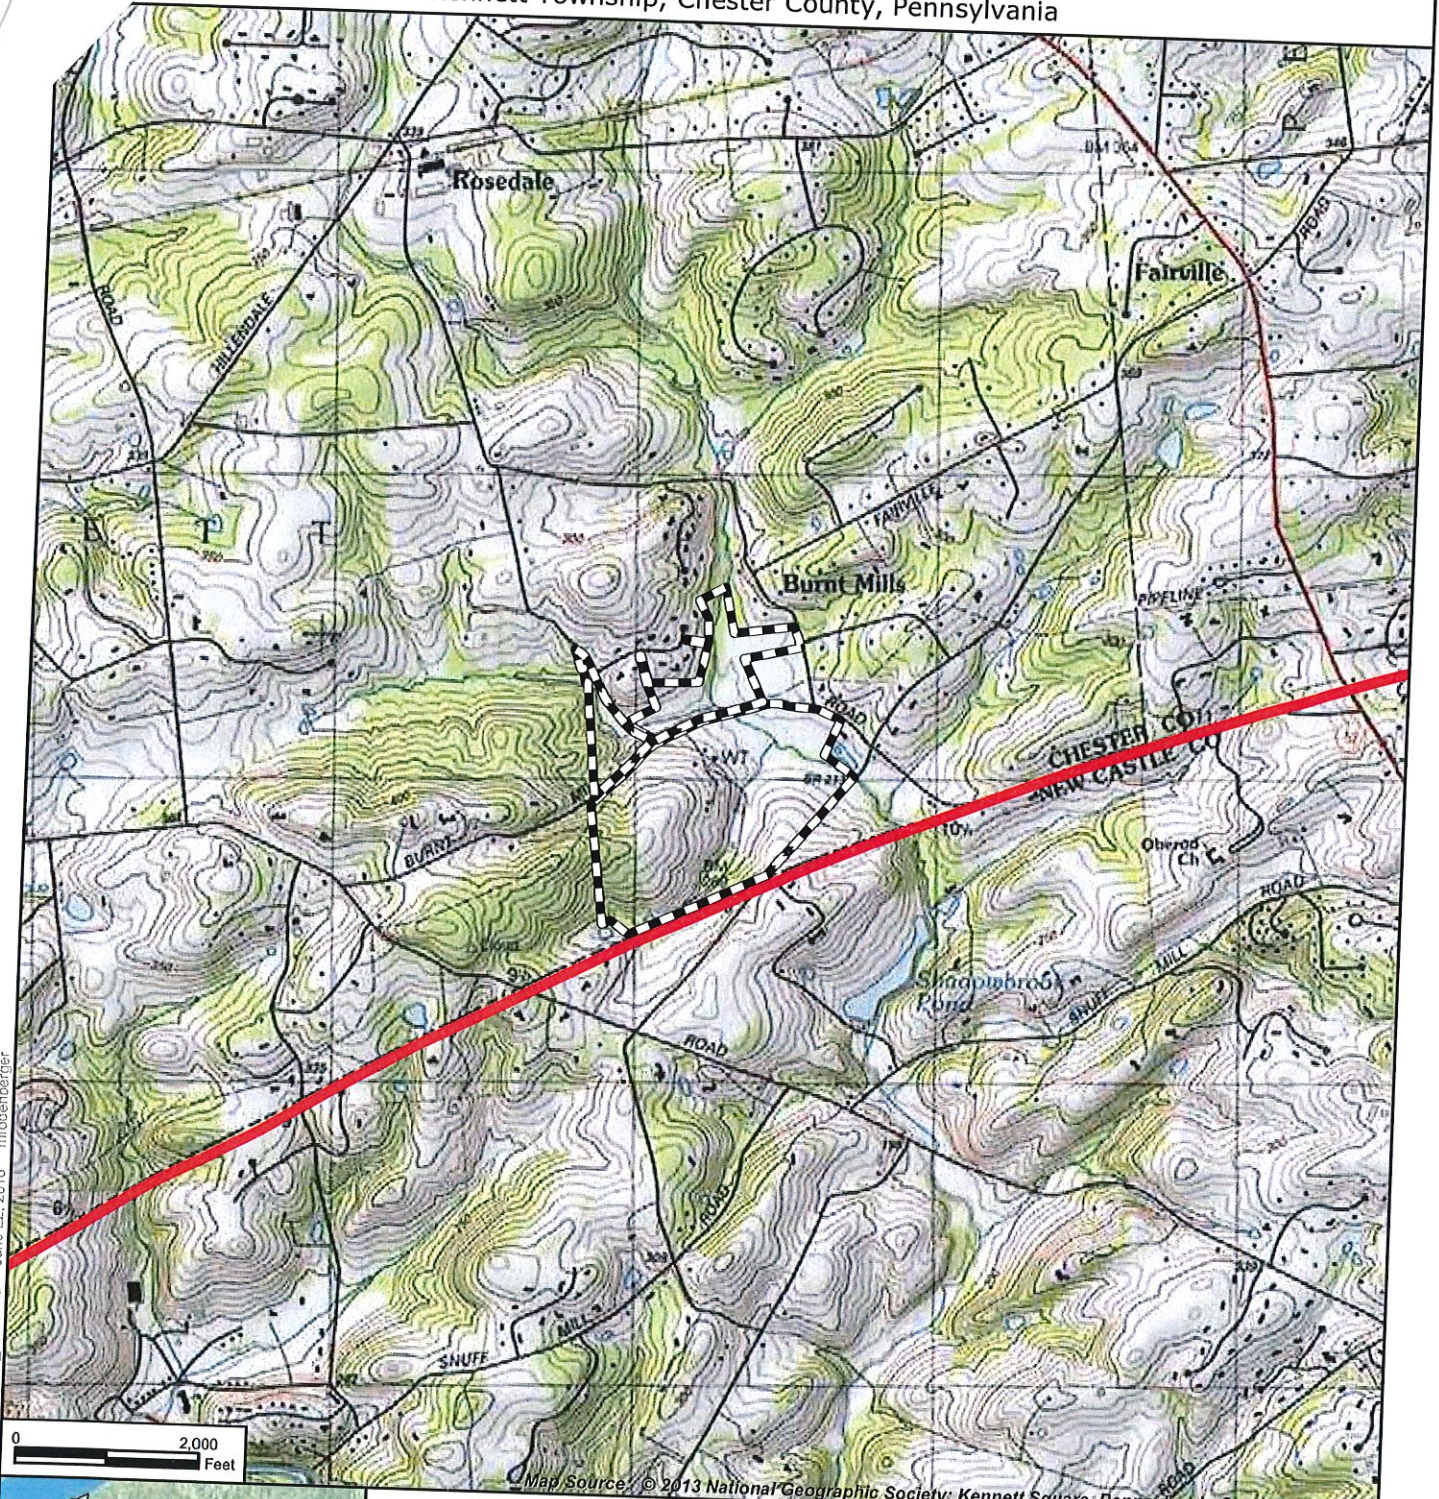
Way Farm
424 Burnt Mill Road and 605 Norway Road
Kennett Township, Chester County, Pennsylvania

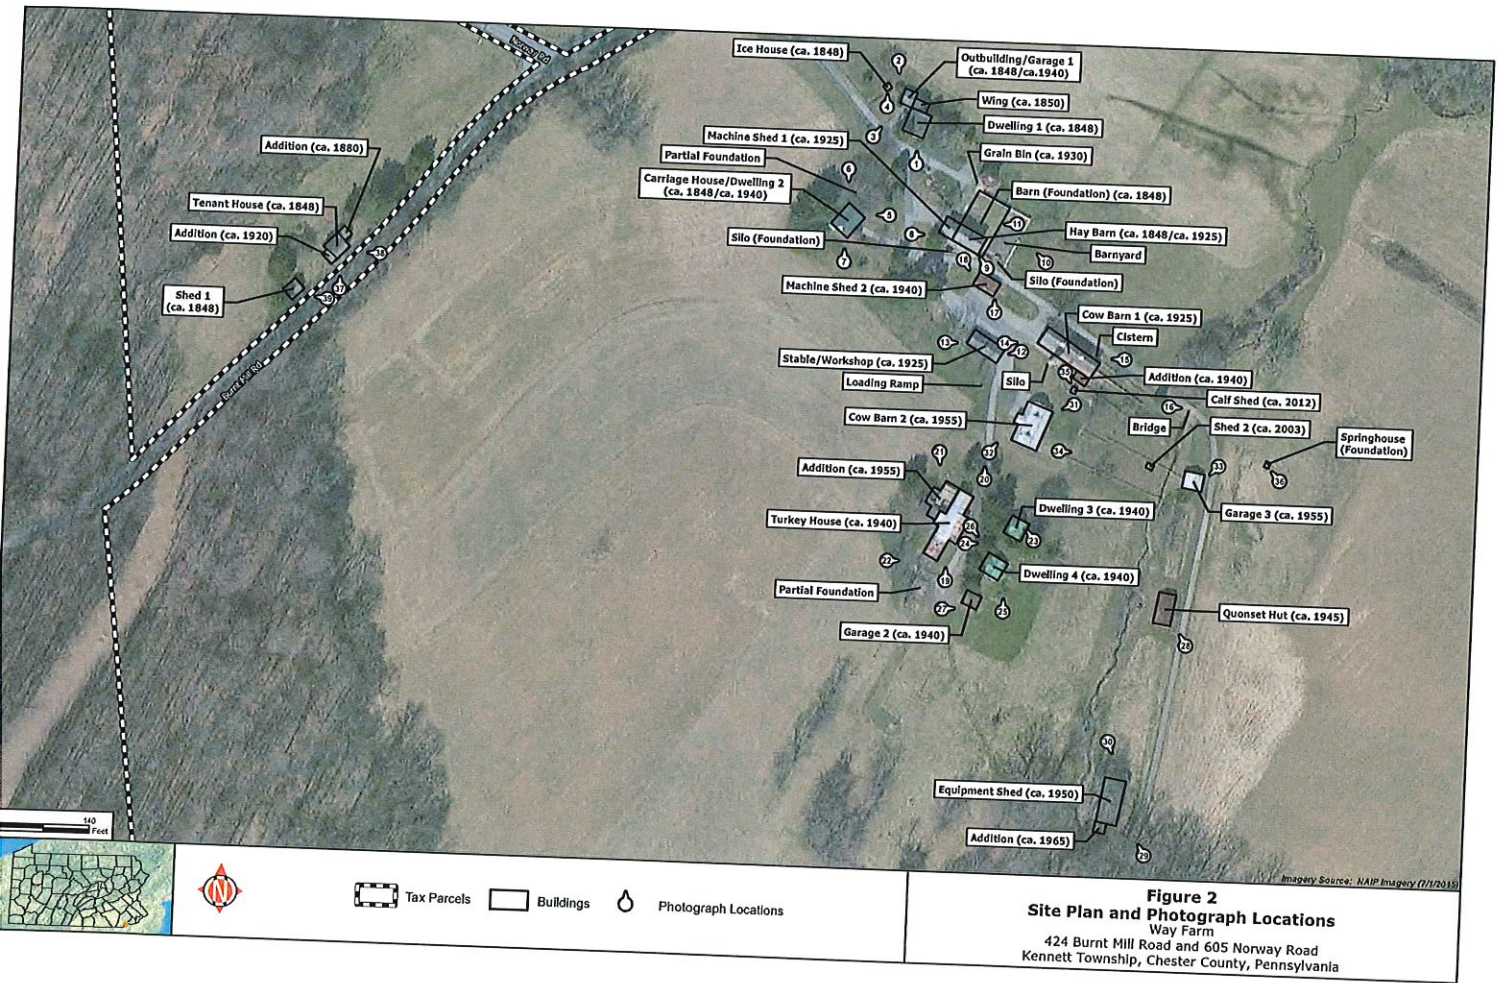
Figure 3
Way Farm, 1937

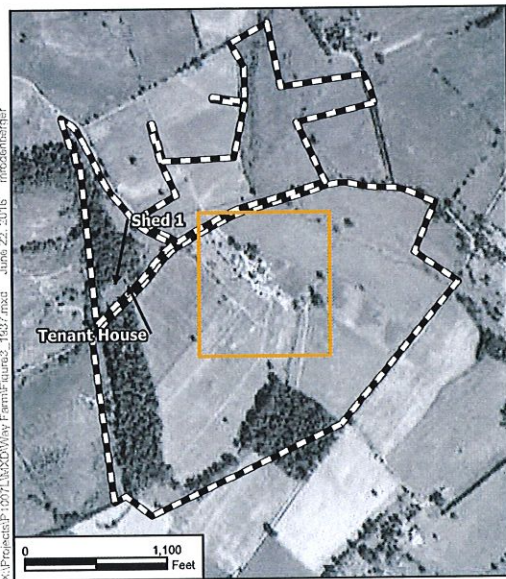
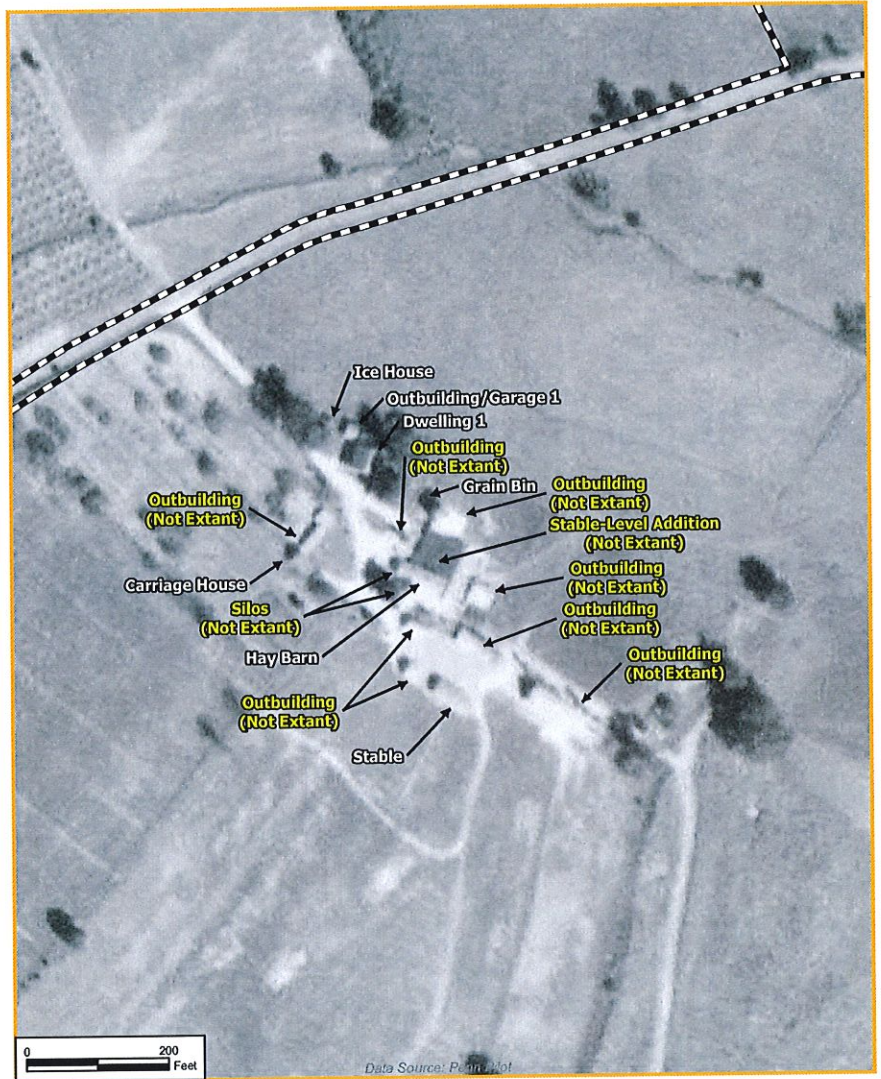
**Figure 4
Way Farm, 1950**

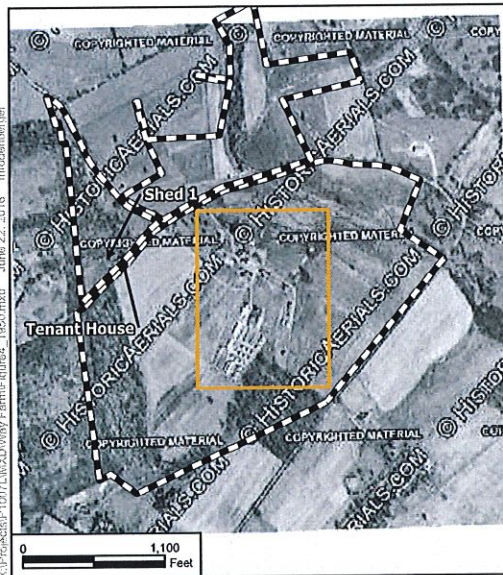
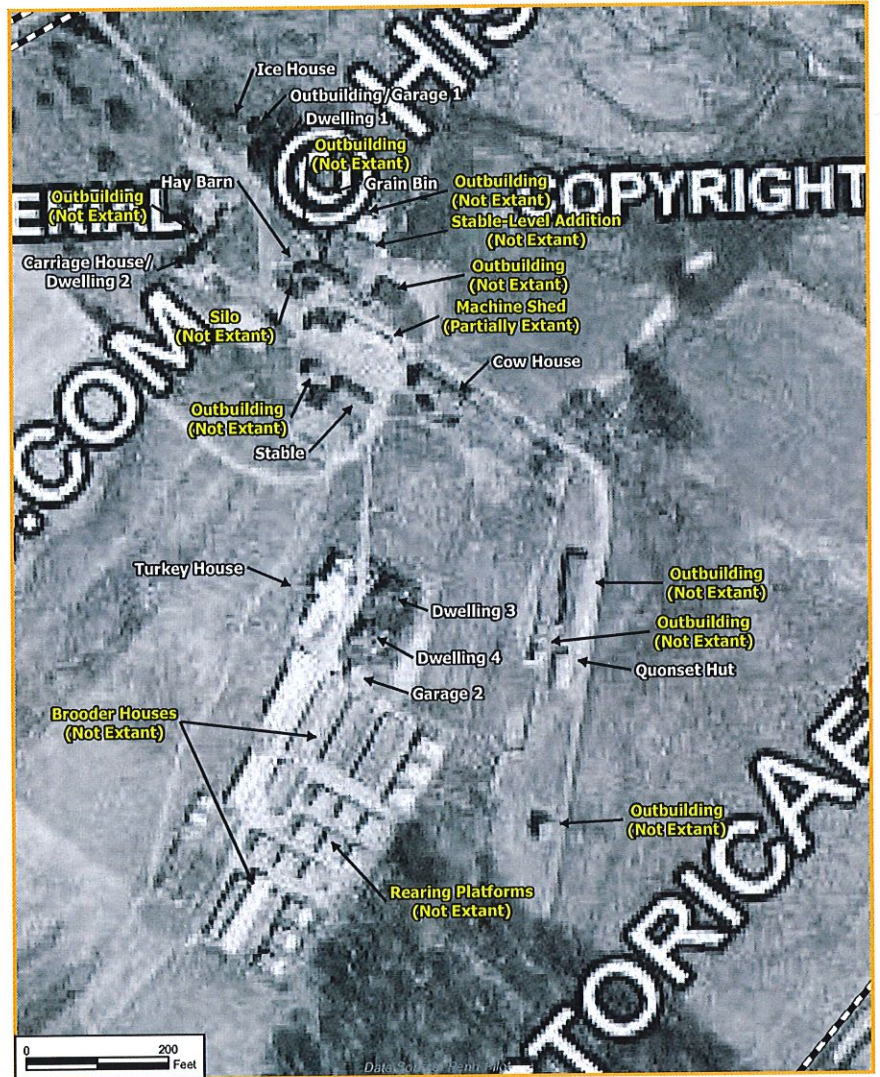
Figure 5 Way Farm, 1958

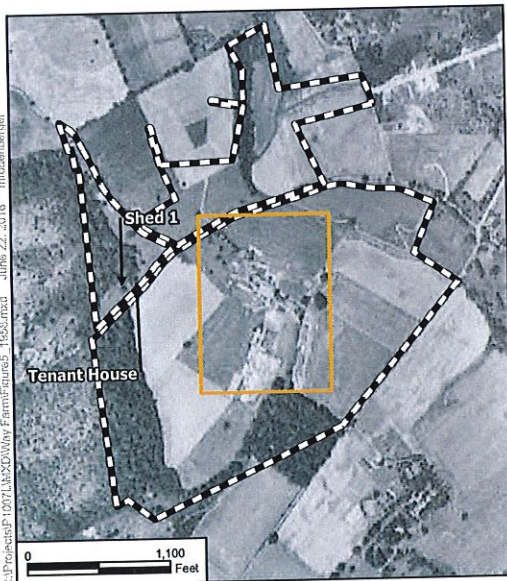
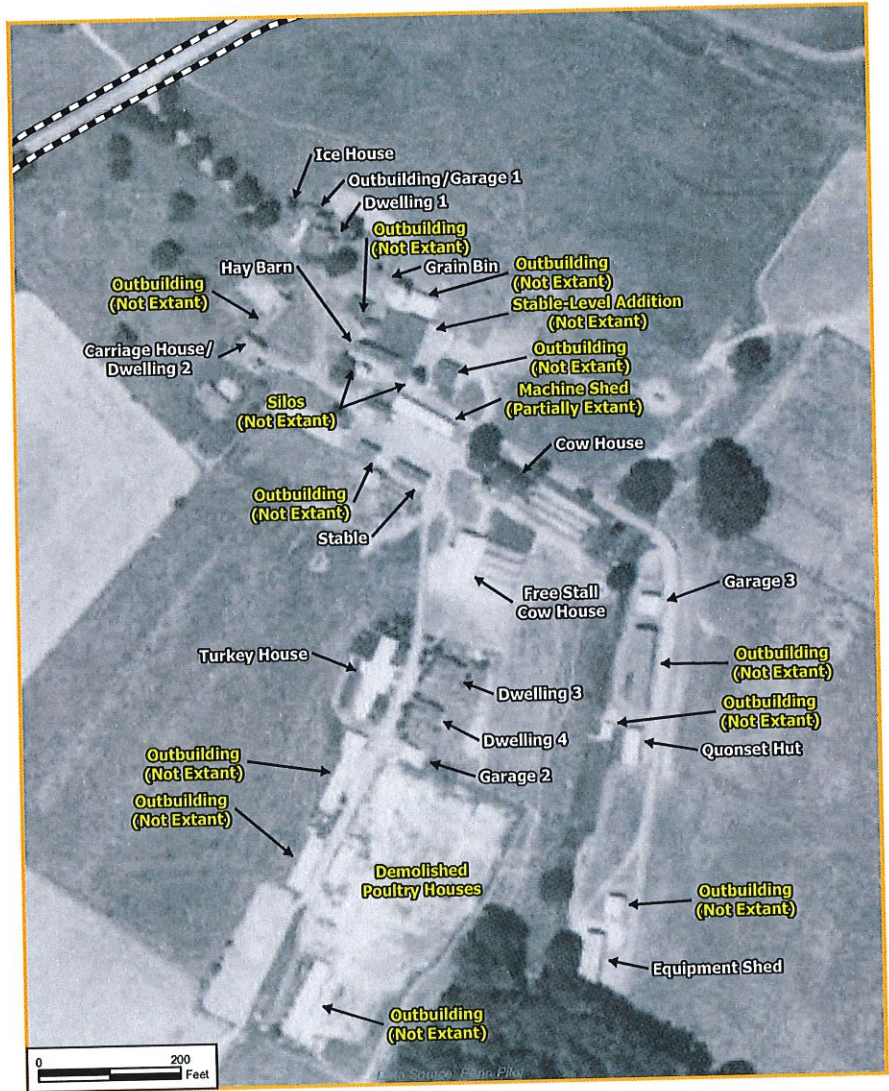
**Figure 6
Way Farm, 1971**

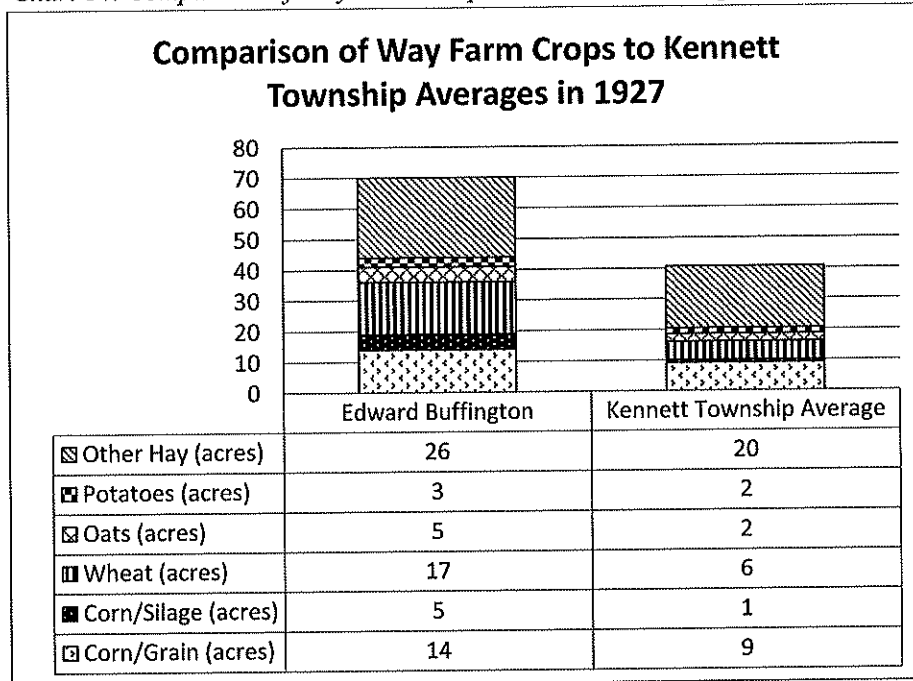
Source: Pennsylvania Department of Agriculture

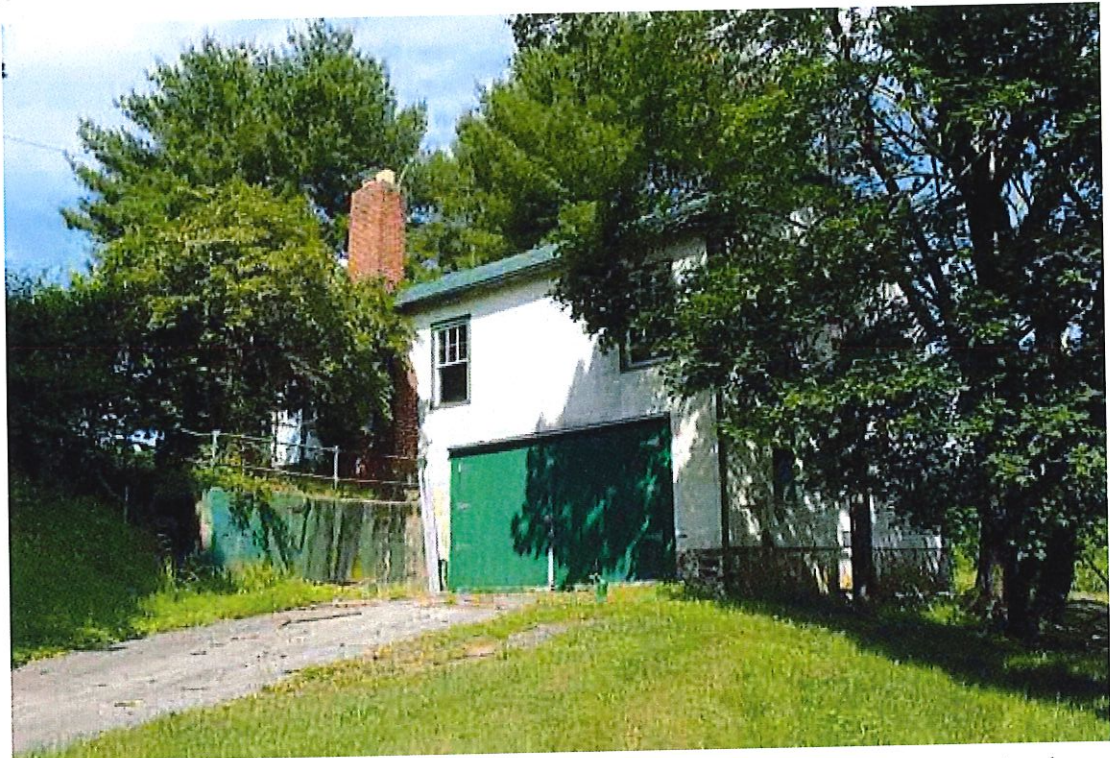
Photograph 5: View of the southeast (front) and northeast (side) elevations of the *circa*-1848 carriage house / *circa*-1940 dwelling 2, facing west. Note the stone foundation at the northern end of the building (right). The first story of this building was built for use as a carriage house. Ca. 1940, the second story apartment was added (June 2016).

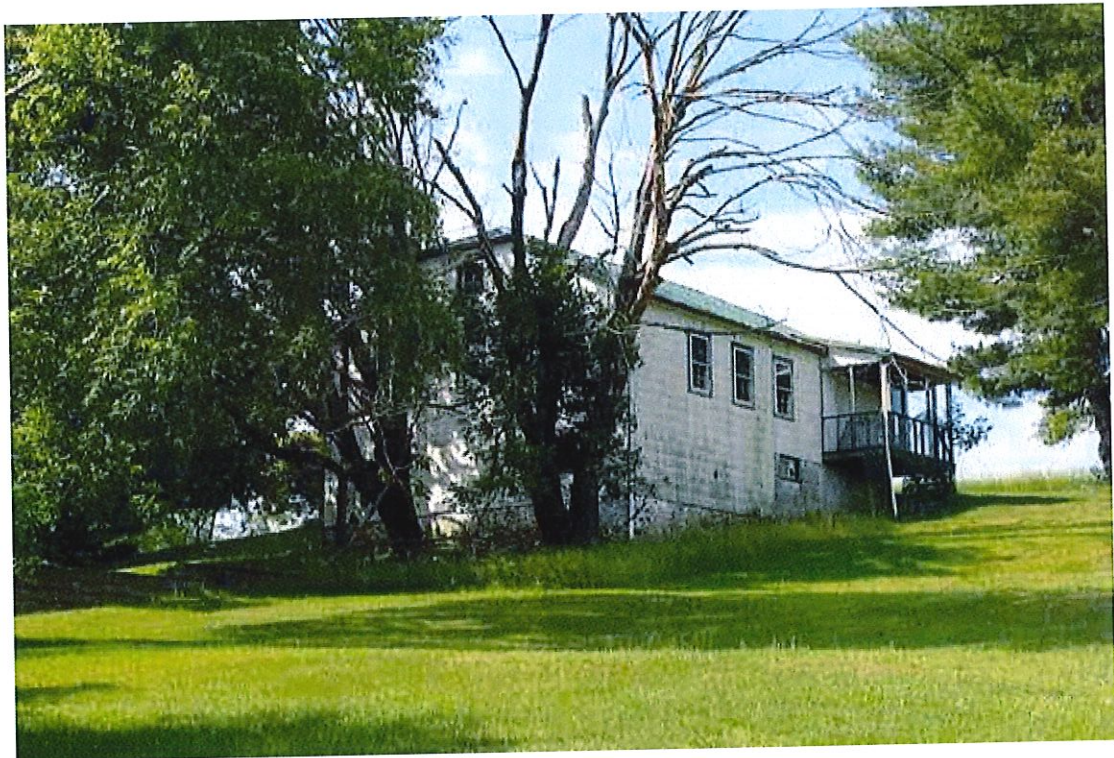
Photograph 6: View of the northeast (side) and northwest (rear) elevations of *circa*-1848 carriage house 1/ *circa*-1940 dwelling 2, facing south. Note the change in foundation material approximately half way along the northwest elevation showing the *circa*-1940 second-story apartment addition (June 2016).

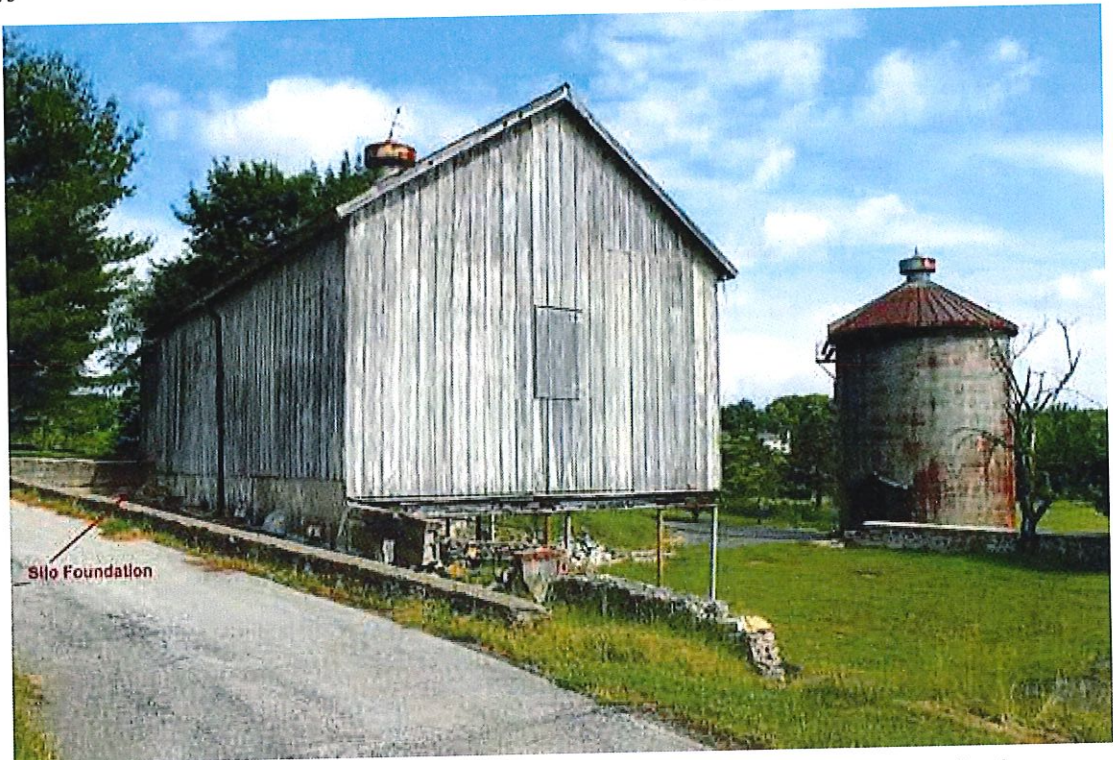
Photograph 9: View of the southwest (left) and southeast (right) elevations of the *circa*-1925 hay barn, facing northwest. Note the foundation under the southwest elevation. The building has a low concrete block foundation on top of an older stone foundation. In front of the concrete wall at the far left of this photograph is the stone foundation of a now-demolished silo. Note also the *circa*-1930 grain bin (at right; June 2016).

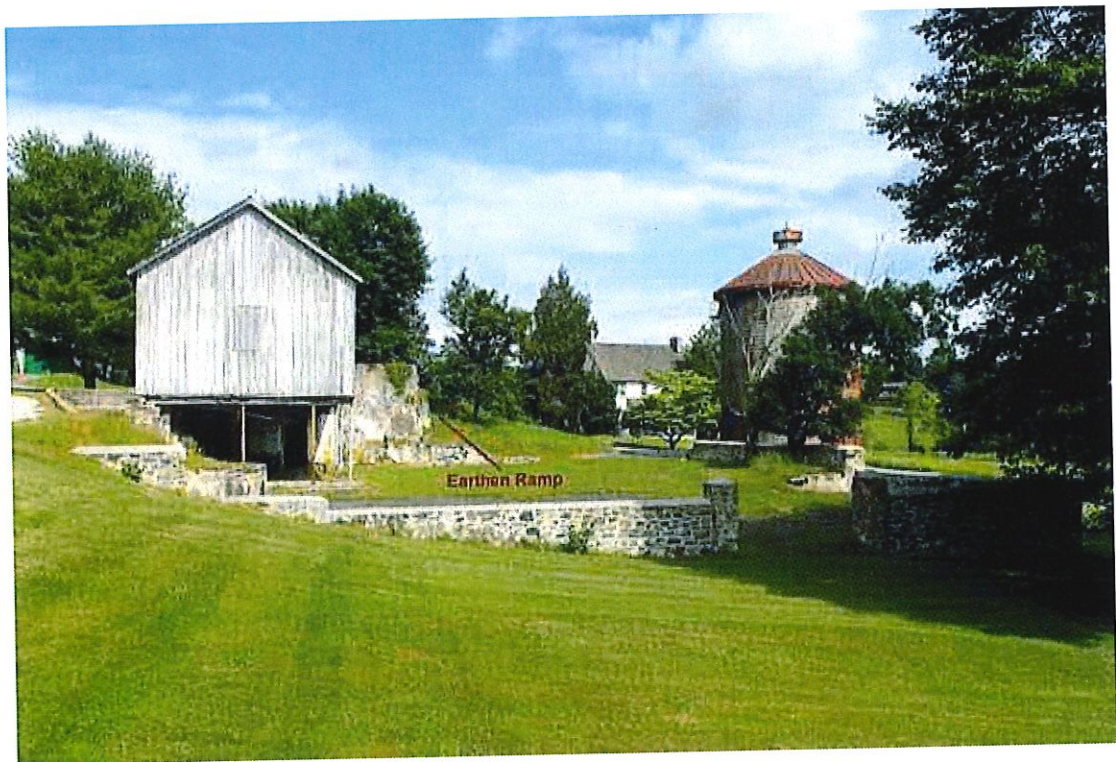
Photograph 10: View of the nineteenth-century barnyard facing northwest showing the southeast elevation of the *circa*-1925 hay barn and the *circa*-1930 grain bin. Note the evidence of the earlier barn including the remains of the earthen ramp (immediately right of the hay barn), the stone foundations (background), and stone-barnyard wall (foreground; June 2016).

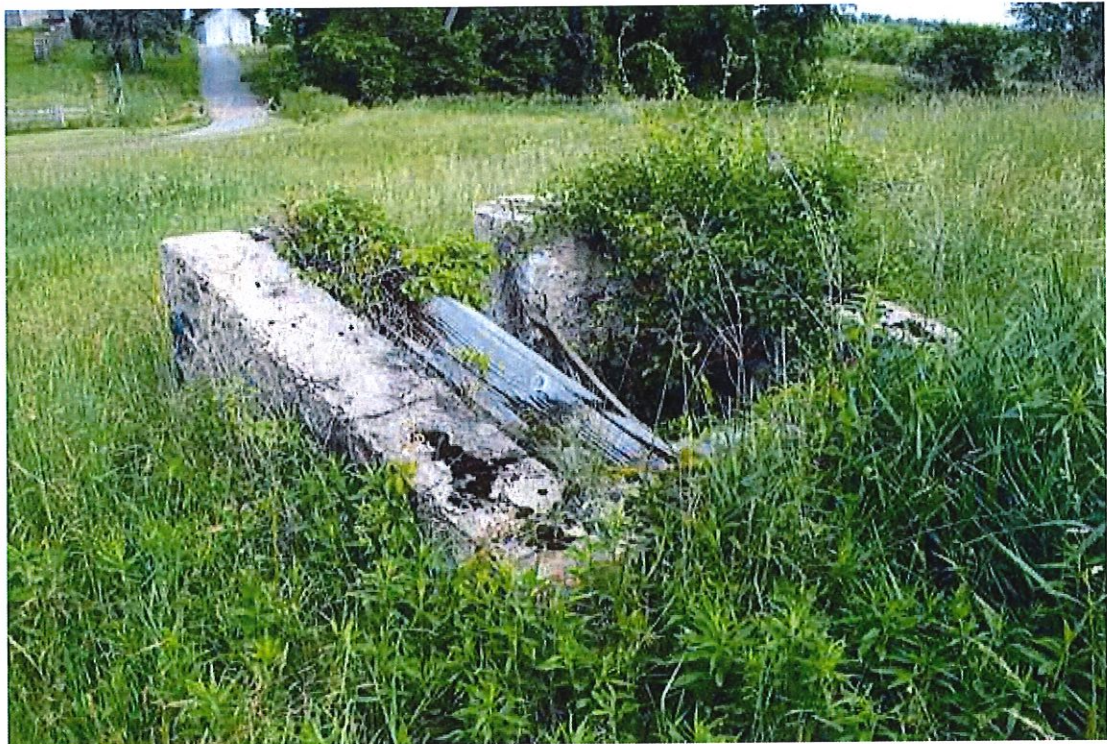
Photograph 36: View of the remains of the stone foundation of a nineteenth-century spring house, facing northwest. Water is still present at the bottom of the structure. The *circa*-1925 hay barn is visible in the background (June 2016).

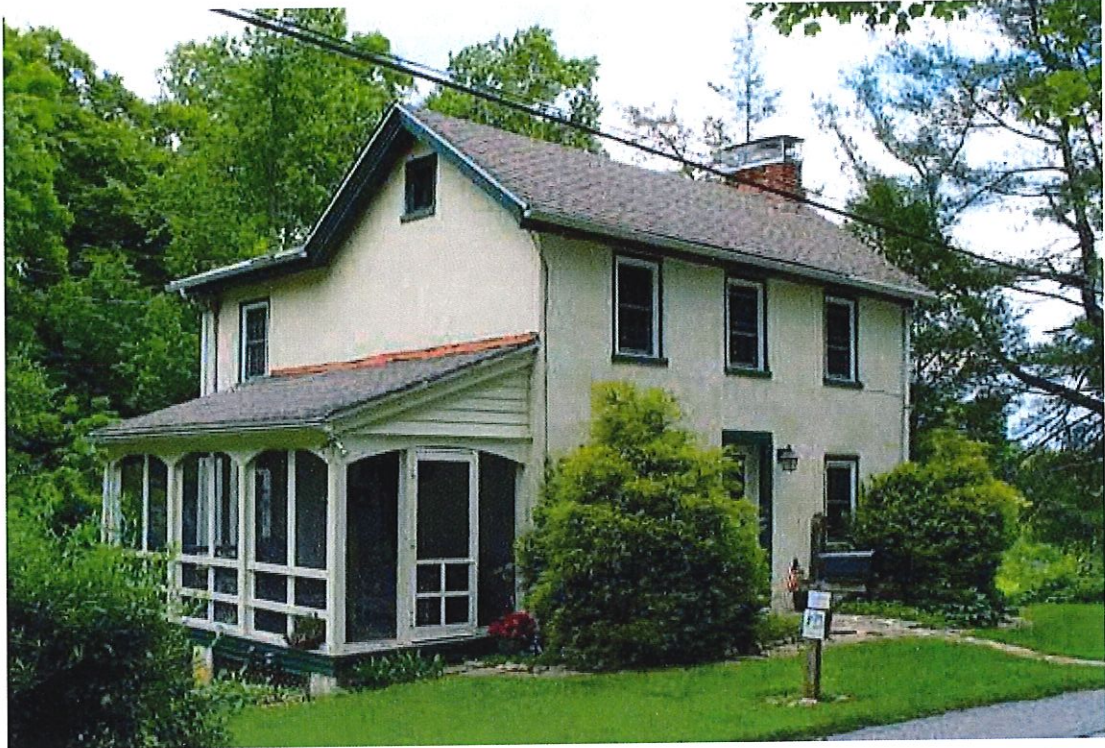
Photograph 37: View of the southwest (side) and southeast (front) elevations of the *circa*-1848 tenant house at 605 Norway Road, facing north. Note the one-story *circa*-1920 shed-roof porch addition and the two-story *circa*-1860 rear addition (June 2016).
